HARPER HOME INSPECTIONS

RESIDENTIAL

1234 Sample Report
Inlet Beach, FL 32461

Casey Willis
MARCH 14, 2023

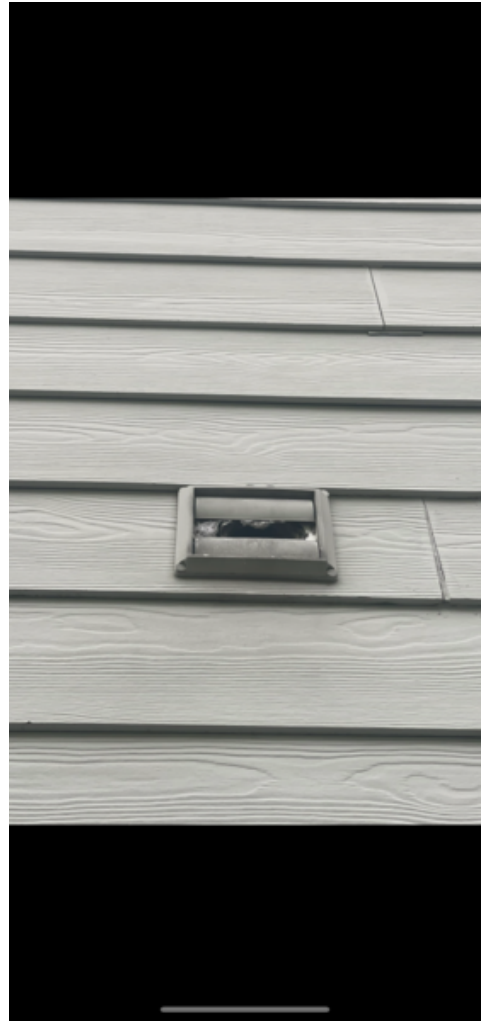
3.3.1 Exterior issues

EXTERIOR DRYER VENT COVER

The exterior cover to the dryer exhaust on the right side of house has a broken flap and it should be replaced to prevent any kind of pests from entering.

Contact a handyman or DIY project

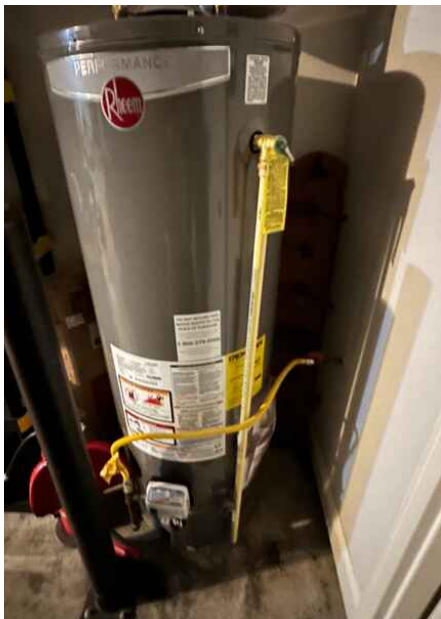
Water Heater: Pictures of Unit

Garage

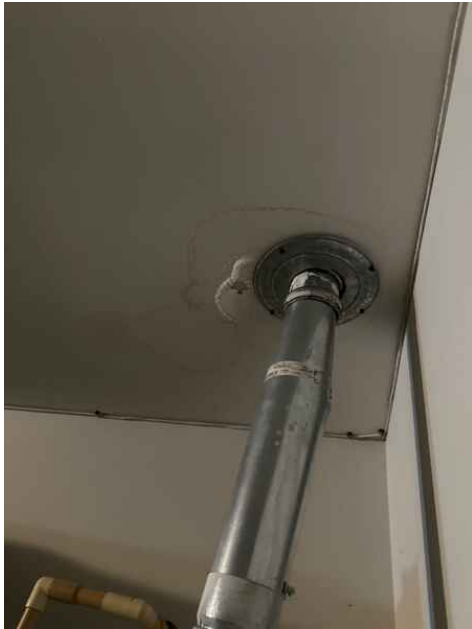
5.1.1 Water Heater

FLUE-CEILING

GARAGE

Ceiling damage observed at flue where it goes through the ceiling. Recommend plumber evaluate/repair/replace the water heater system and/or its components due to the age and findings during the inspection.

Contact a qualified professional.

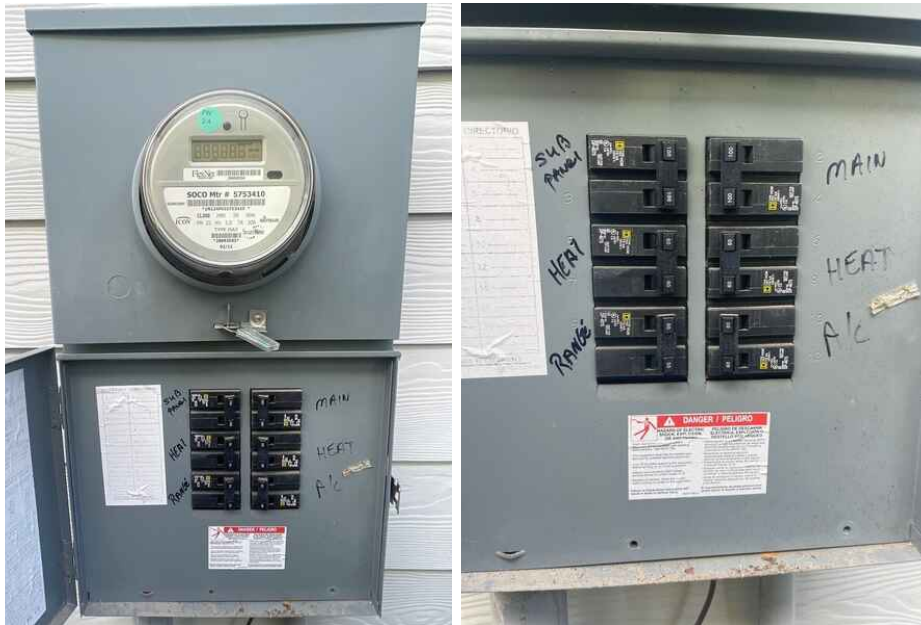
Electric Panel: Panel pictures

Exterior - Right Side of House

Main panel and cut off is in the box under the meter on right side of house.

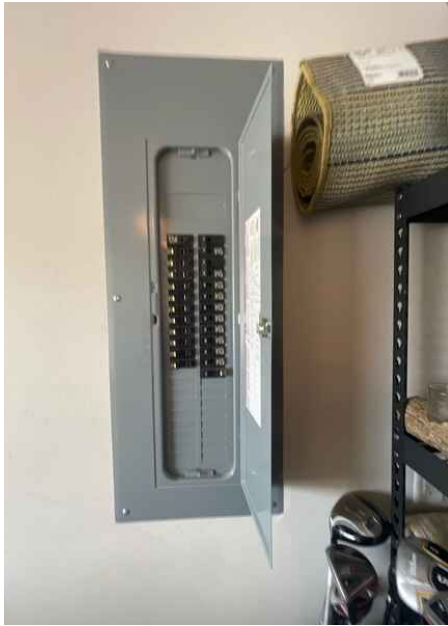
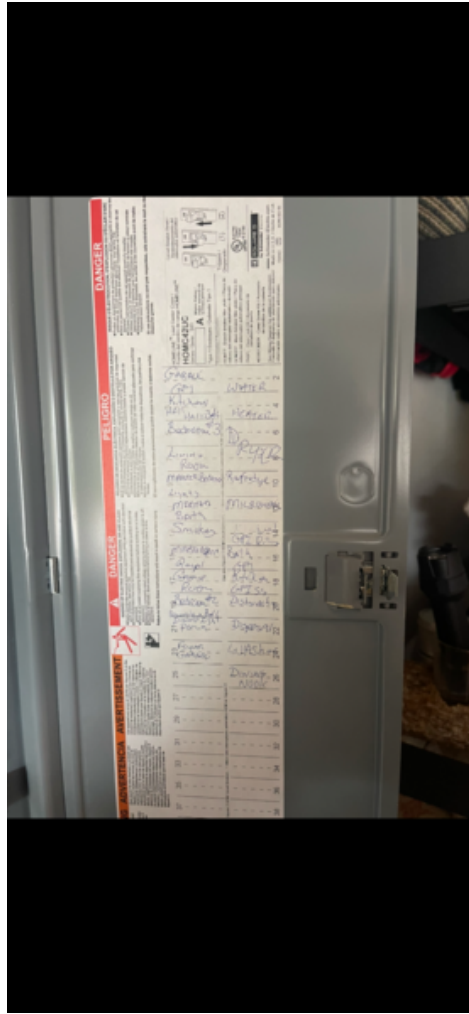
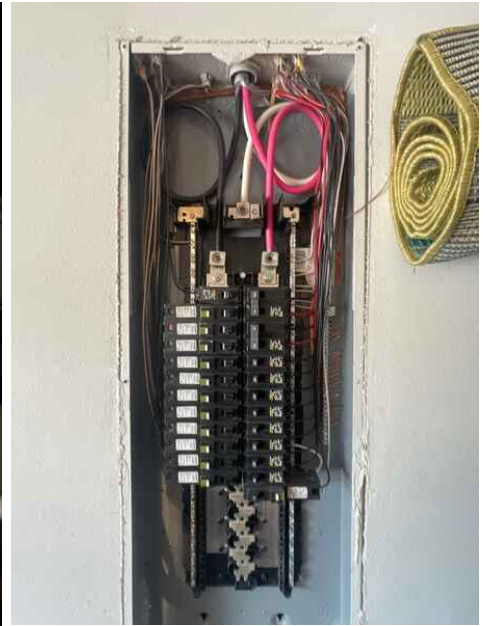
Electric Panel: Sub panel

Garage

Sup panel is in Garage on north wall. No issues observed.

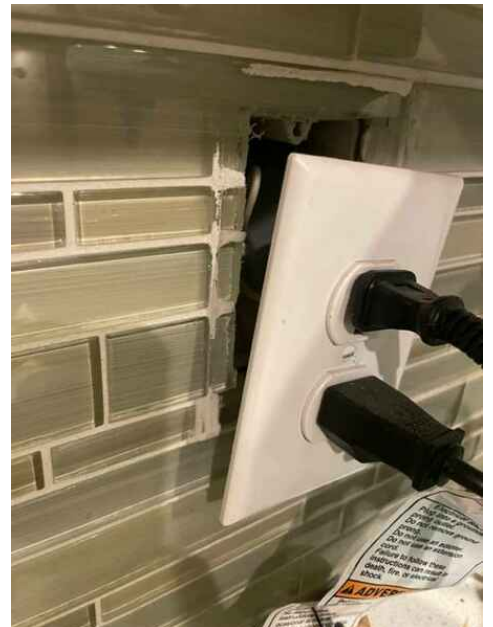
8.3.1 Electrical

RECEPTACLE LOOSE

ALONG BACKSPLASH NEAR REFRIGERATOR

One or more electric receptacles and/or the boxes they are installed in are loose and/or not securely anchored. Wire conductors may be damaged due to repeated movement and/or tension on wires, or insulation may be damaged. This is a safety hazard due to the risk of shock and fire. A qualified electrician should evaluate and repair as necessary.

Contact a qualified electrical contractor.

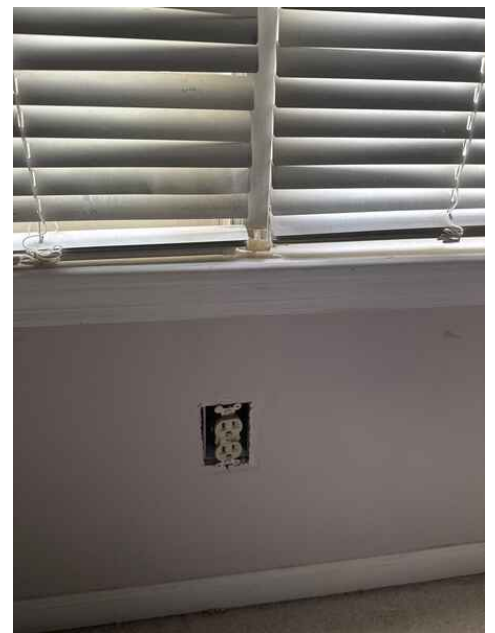
9.1.1 Electrical

COVER PLATE MISSING

BONUS ROOM UPSTAIRS

Cover plate(s) are missing from one or more electric boxes, such as for receptacles, switches and/or junction boxes. They are intended to contain fire and prevent electric shock from exposed wires. This is a safety hazard due to the risk of fire and shock. Cover plates should be installed where missing.

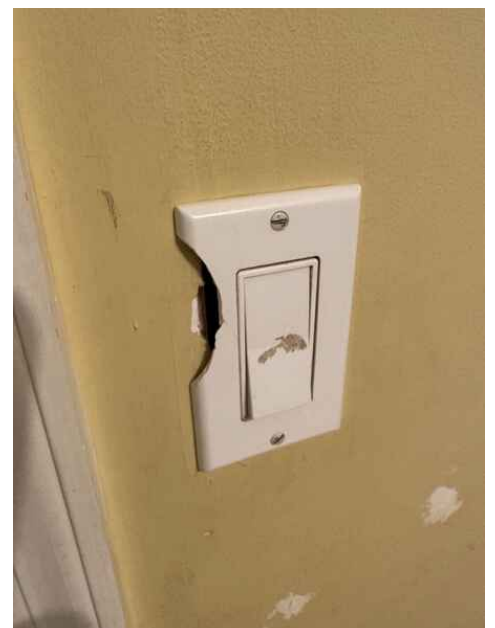
9.1.2 Electrical

LIGHT SWITCH COVER DAMAGED

BEDROOM 3

The light switch cover is damaged and should be replaced..

Contact a handyman or DIY project

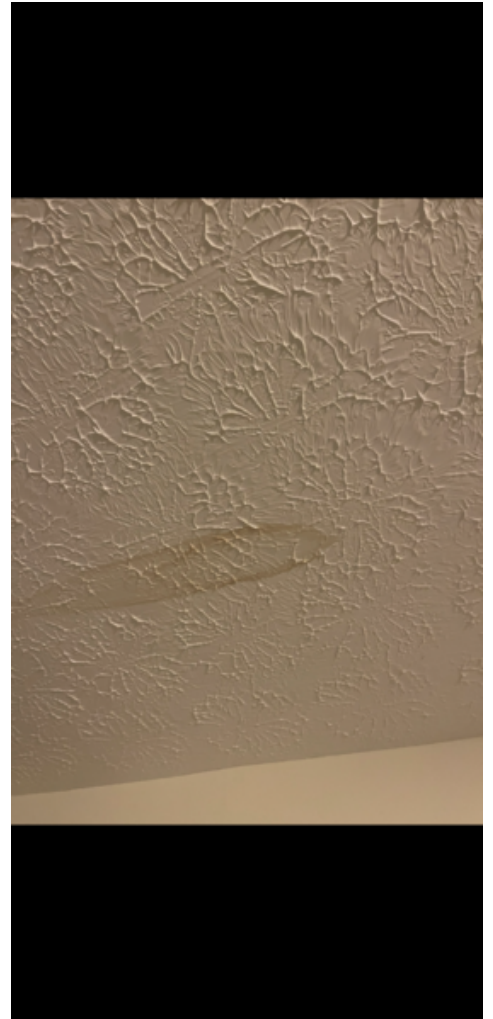
9.2.1 Floors, Walls, Ceilings

CEILING-DRY STAINS

Stains were found in one or more ceiling areas. However, no elevated levels of moisture were found. The stain(s) may be due to past roof and/or plumbing leaks. Recommend asking the property owner(s) about this, and monitoring the stained area(s) in the future, especially after heavy or prolonged rain. If elevated moisture is found in the future, a qualified contractor should evaluate and repair as necessary.

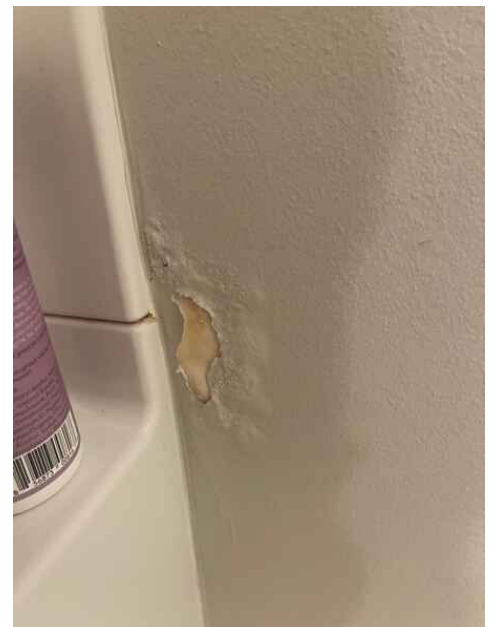
10.1.2 Bathtub

WATER DAMAGE WALL

The floor / wall by the bathtub was water-damaged. Paint is peeling but the drywall is still solid. Recommend that a qualified person repair as necessary.

Contact a qualified painting contractor.

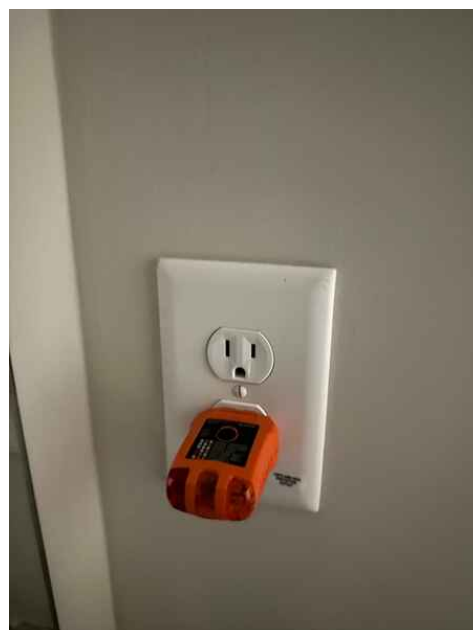
10.3.3 Electrical

**RECEPTACLE NO POWER**

One or more electric receptacles appear to have no power. Recommend asking the property owner(s) about this. Switches may need to be operated to make some receptacles energized. If necessary, a qualified electrician should evaluate and make repairs as necessary.
